MeadowWood
Common Areas
Liberty Lake, WA

Report #: 32516-1
Beginning: January 1, 2024
Expires: December 31, 2024

RESERVE STUDY
Update "With-Site-Visit"

December 15, 2023

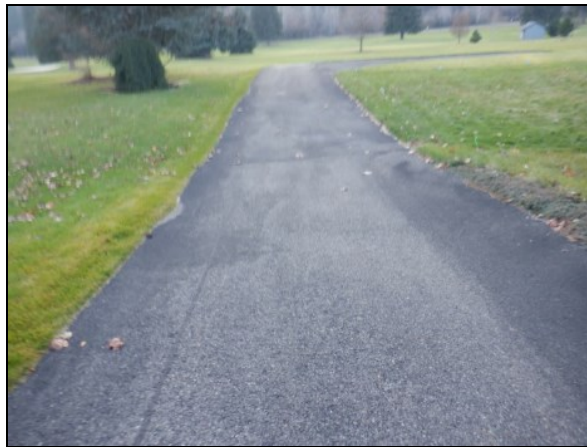
Comments: Asphalt appeared generally intact with localized lateral and hairline cracking.
