MeadowWood
Garden Ridge
Liberty Lake, WA

Report #: 32516-1
Beginning: January 1, 2024
Expires: December 31, 2024

RESERVE STUDY
Update "With-Site-Visit"

December 15, 2023

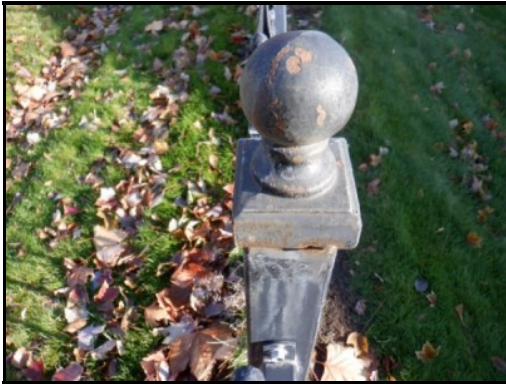
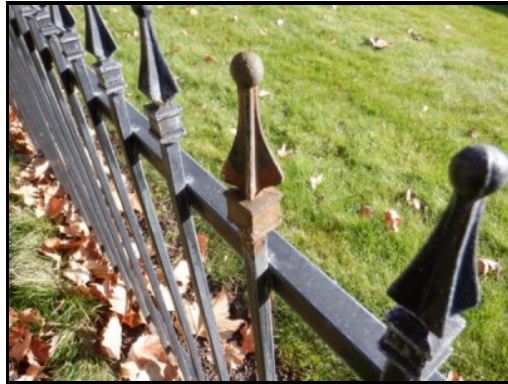
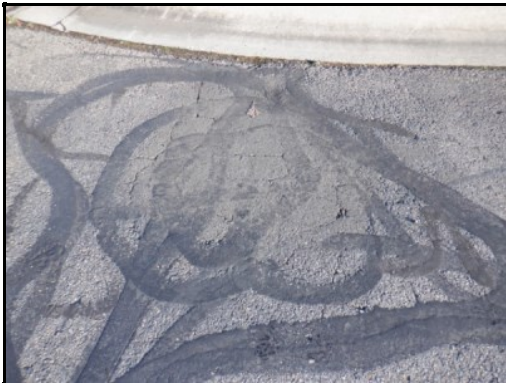
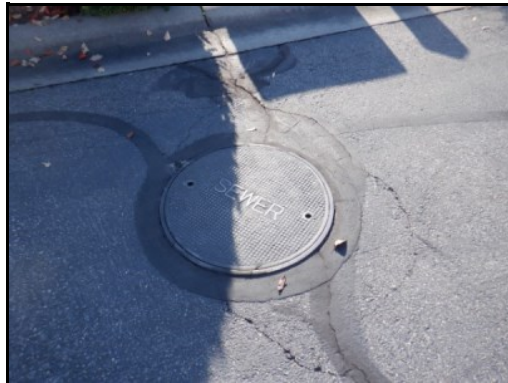
During our site visit on 11/17/2023, we visually inspected all visible common areas, while compiling a photographic inventory, noting: general exterior observations, make & model information where appropriate, apparent levels of care and maintenance, exposure to weather elements and other factors that may affect the components useful life.

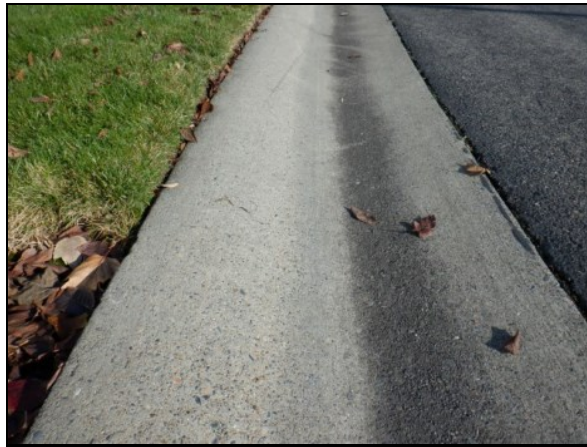
Comp #: 100 Concrete - Repair/Replace

Comments: Small localized areas of spalling concrete and minor tripping hazards, however no major cracking or deterioration observed.

As routine maintenance, inspect regularly and pressure wash for appearance. Repair any trip hazards (1/2" difference in height) immediately to ensure safety. Repair promptly as needed to prevent water penetrating into the base, which can cause further damage. Factors affecting the quality, service life of the concrete include; the preparation of the underlying soil and drainage, thickness and strength of concrete used, steel reinforcement (none likely), amount and weight of vehicle traffic, if any and tree roots nearby.

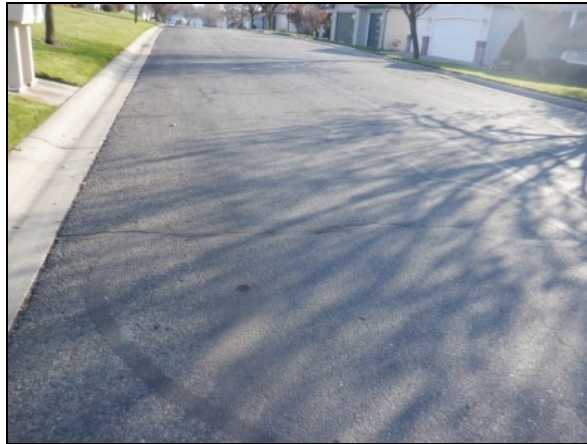
Comments: Asphalt appeared generally intact at the time of our site visit with no small areas of structural alligator cracking observed at the entrance of the community (see component #121 for additional comments on cracking).

Useful life below assumes regular seal coating and repairs (see component #121). The lack of seal coating and repairs can greatly decrease the asphalt's useful life. Resurfacing is typically one of the larger expense items in a reserve study. When need to resurface is apparent within a couple of years, consult with geotechnical engineer for recommendations, specifications/scope of work and project oversight.

As routine maintenance, keep surfaces clean and free of debris, ensure that drains are free flowing, repair cracks, and clean oil stains promptly. Assuming proactive maintenance, plan to resurface at roughly the time frame below.

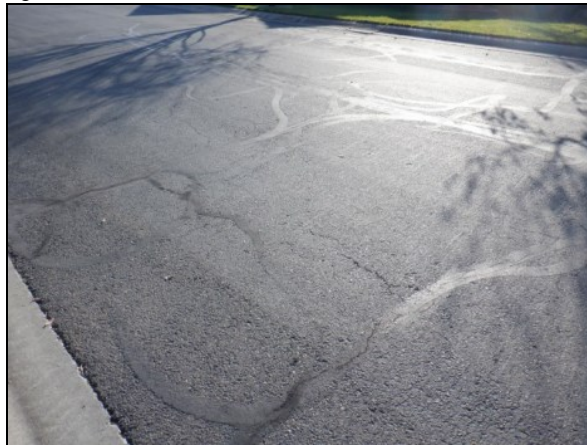
Comments: Asphalt seal appeared faded with failing crack fill throughout the roads. Major areas of lateral and hairline cracking observed at the corner of N Tanglewood Ln and E Eagle Bend Ln.

Regular cycles of seal coating, along with needed repairs is a best practice for the long term care of lower traffic asphalt areas to extend the useful life.

Repairing asphalt before seal coating is imperative. Surface preparation and dry weather during and following application is key to lasting performance.

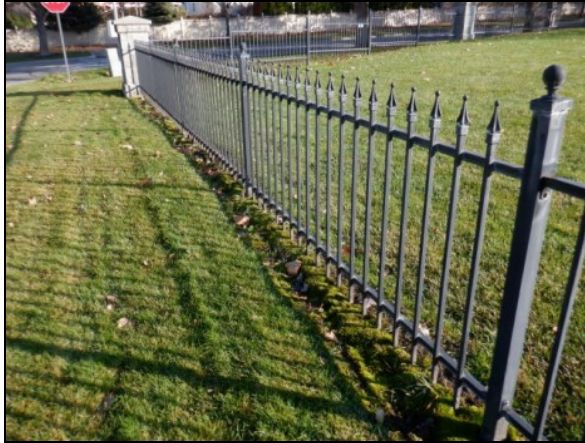
Comp #: 143 Metal Fence - Replace

Comments: Metal fencing appeared to be in fair condition, with no obvious signs of instability significant displacement during our site inspection.

We suggest planning for total replacement at approximately the time shown below. As remaining useful life approaches zero years, evaluate the fence and adjust life accordingly.

Routinely inspect for stability, security, and appearance. Repair locally as needed as part of general maintenance.

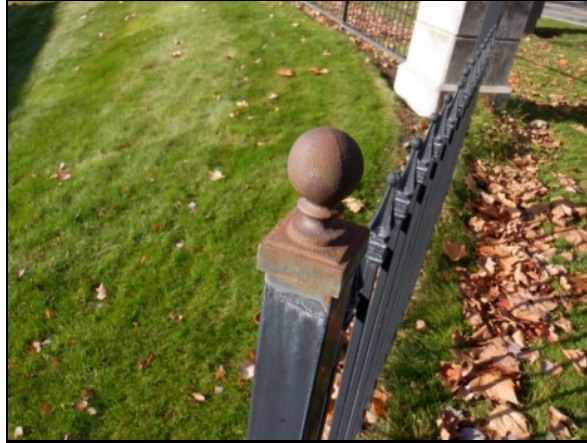
Comments: The painted metal fence appeared to have faded or completely missing areas of paint with exposed rusting elements of fence (see photo). Recommended to pursue painting estimates as soon as possible to prevent further corrosion.

Touch up paint, and secure any fasteners as needed as part of general maintenance. If corrosion is found, apply rust inhibitor to prevent corrosion, and extend the useful life.

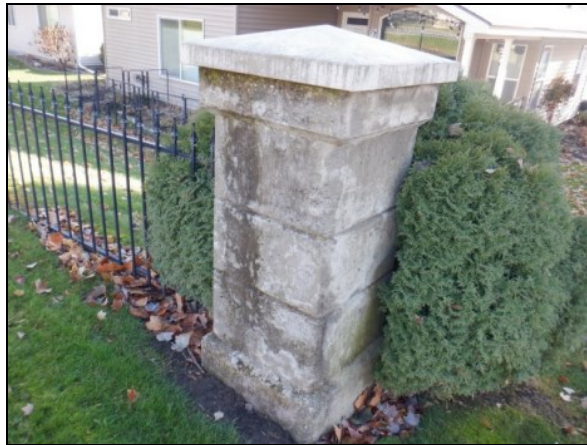
Comp #: 147 Concrete Pillars - Repair/Replace

Comments: concrete pillars appeared to be generally intact with moderate grime and organic growth observed throughout. We recommend cleaning with fence paint project outlined in component #145.

There is no basis to expect complete replacement within the scope of this report, therefore maintain, repair and replace as needed utilizing general maintenance operating funds.

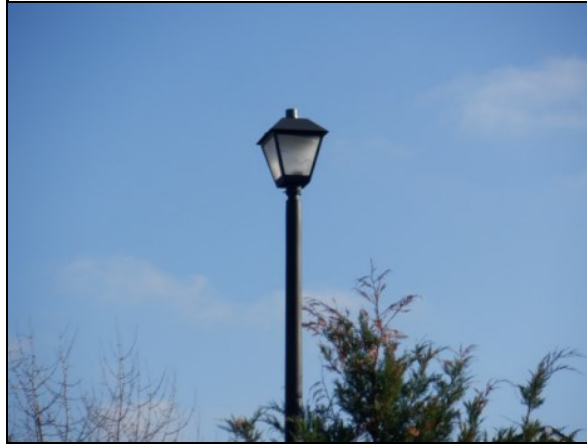
Comp #: 160 Pole Lights - Replace

Comments: It was previously reported that pole lights are the responsibility of Avista Utilities to maintain, repair and replace, therefore no reserve funding included.

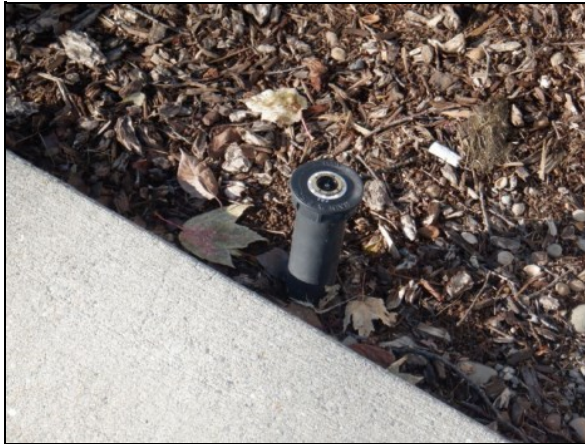
Comp #: 175 Irrigation System - Repair/Replace

Comments: Our visual observation of the irrigation system was limited as the majority of system components are below grade. No reports of repairs or problems. At the time of this study, no information (plans and/or specifications) was provided to us regarding the extent of the irrigation system.

No predictable large-scale costs at this time, however we have included a rotating allowance for larger repairs as requested by client. Have your landscaper or irrigation specialist periodically unearth sections to check lines for any damage or deterioration. PVC can eventually become brittle and leak (typically not before the 40 year mark of life).

As routine maintenance, inspect, test, and repair the system as needed from the operating budget. Follow proper winterization and spring startup procedures. If properly installed and bedded without defect, the lines could last for many years. Controls for the system can vary greatly in number, cost, and life expectancy - typically each controller is less than \$500. Other elements (i.e. sprinkler heads, valves) within this system are generally lower cost, and have a failure rate that is difficult to predict. These elements are better suited to be handled through the maintenance and operating budget, not reserves.

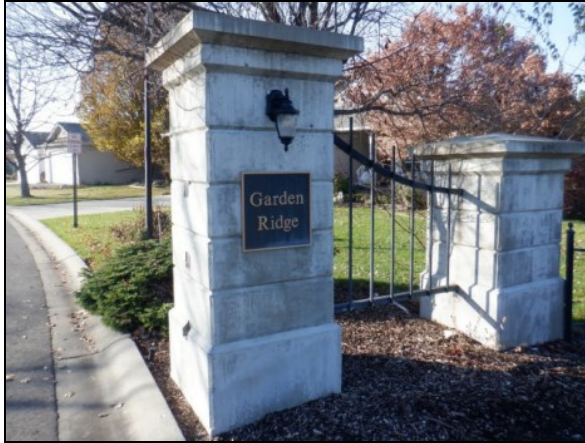
Comp #: 200 Monument Sign - Replace

Comments: Monument consisted of two large concrete block monuments with small metal signs. Monuments also featured lighting. Pillars appeared generally clean with no major signs of spalling or obvious instability.

While there is no basis to expect complete replacement of concrete block monuments, it is reasonable to expect that periodic repairs and lettering replacement will be necessary. A mid-range allowance for periodic refurbishing is below.

Inspect periodically, repair, clean, and touch up for appearance as needed using general maintenance funds.

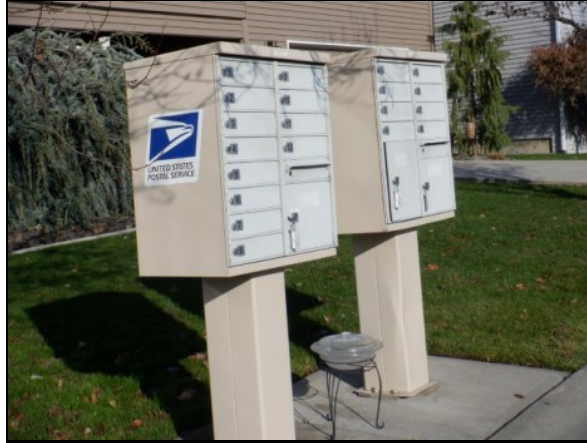
Comp #: 205 Mailboxes - Replace

Comments: Mailboxes appeared in generally fair condition with weathered exteriors, however no obvious signs of instability were observed. Mailboxes are not protected from the weather by a structure.

In our experience, it is best to plan for total replacement at roughly the time frame below due to constant usage and wear over time.

As routine maintenance, inspect regularly, clean by wiping down for appearance, change lock cylinders, lubricate hinges, and repair as needed from the operating budget.
