## Update "With-Site-Visit" Reserve Study

**MeadowWood  
Garden Ridge  
Liberty Lake, WA**

**Report #: 32516-0  
For Period Beginning: January 1, 2021  
Expires: December 31, 2021**

**Date Prepared: August 12, 2020**

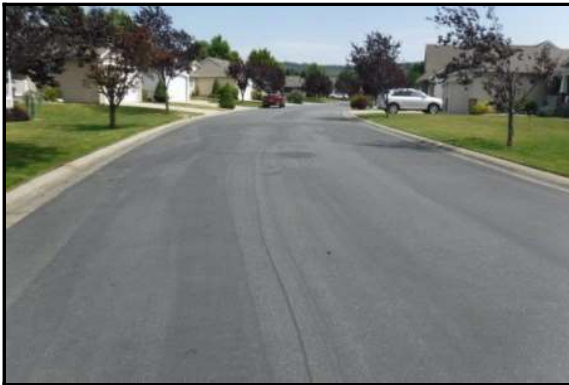
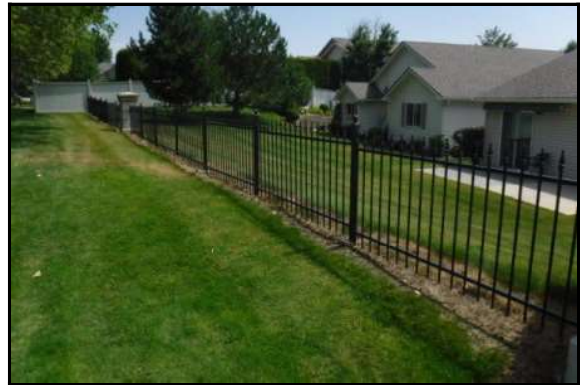
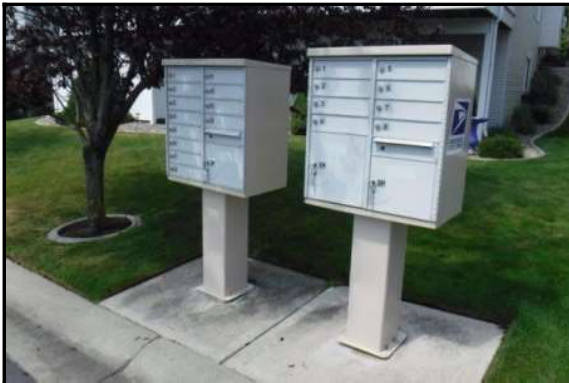
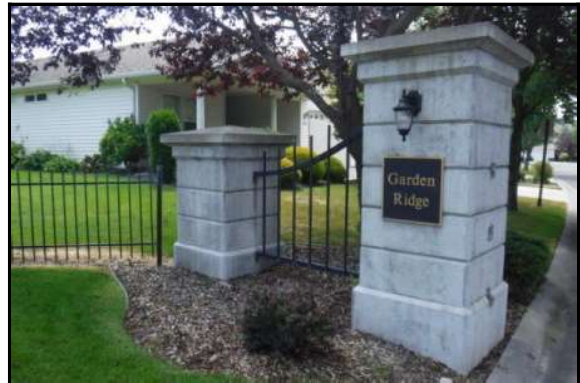
During our site visit on 7/28/2020, we visually inspected all visible common areas, while compiling a photographic inventory, noting: current condition, make & model information where appropriate, apparent levels of care and maintenance, exposure to weather elements and other factors that may affect the components useful life.

We did not note any wide scale damage or deterioration of the common elements.

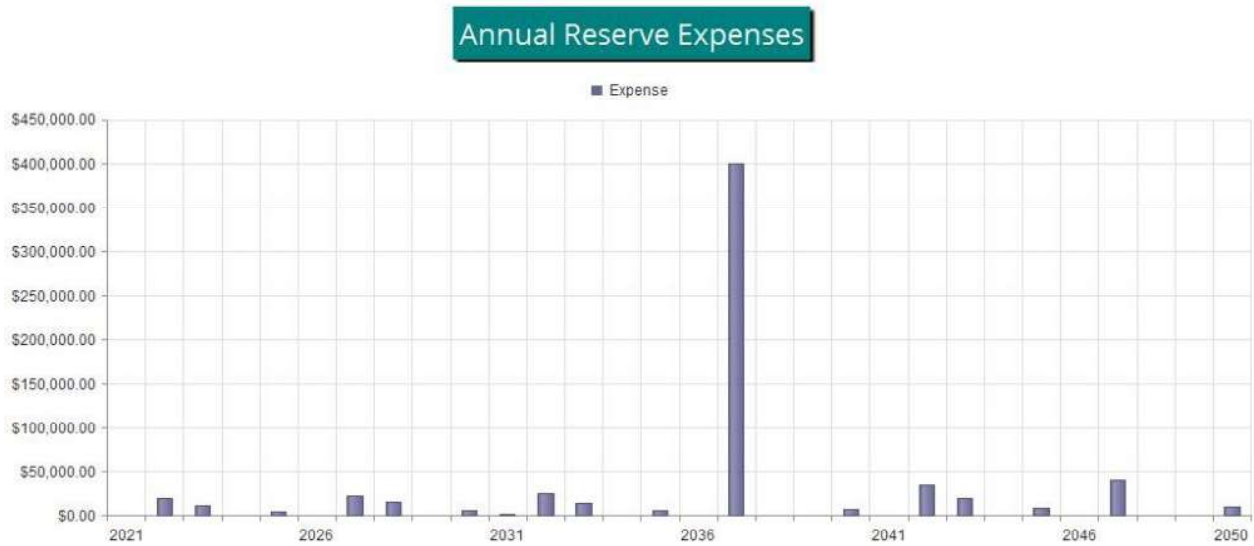
Figure 1

The figure below summarizes the projected future expenses at your association as defined by your Reserve Component List. A summary of these expenses are shown in the 30-yr Summary Table, while details of the projects that make up these expenses are shown in the Cash Flow Detail Table.

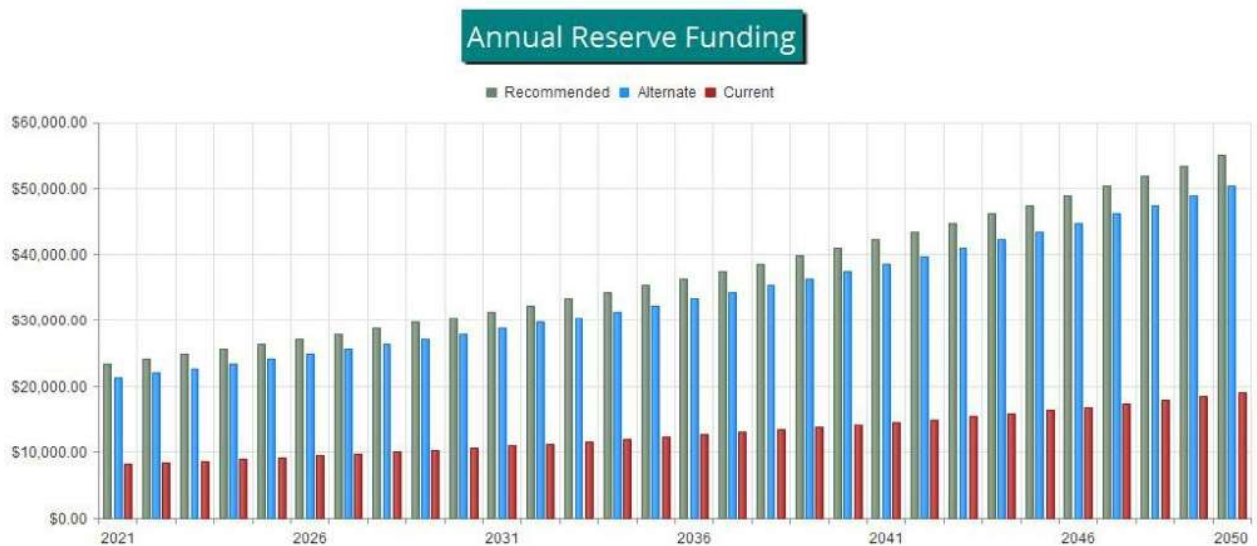
Figure 2

Based on your current Percent Funded and your near-term and long-term Reserve needs, we are recommending budgeted contributions of \$1,948 per month this Fiscal Year. The overall 30-yr plan, in perspective, is shown below. This same information is shown numerically in both the 30-yr Summary Table and the Cash Flow Detail Table.

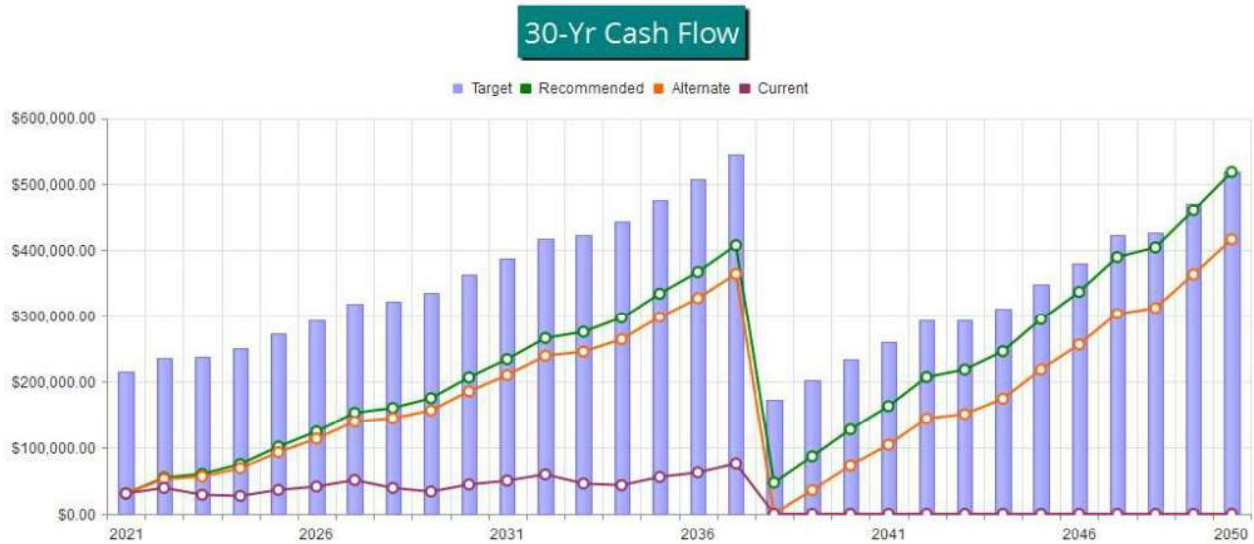
Figure 3

The following chart shows your Reserve balance under our recommended Full Funding Plan, an alternate Baseline Funding Plan, and at your current budgeted contribution rate (assumes future increases), compared to your always-changing Fully Funded Balance target.

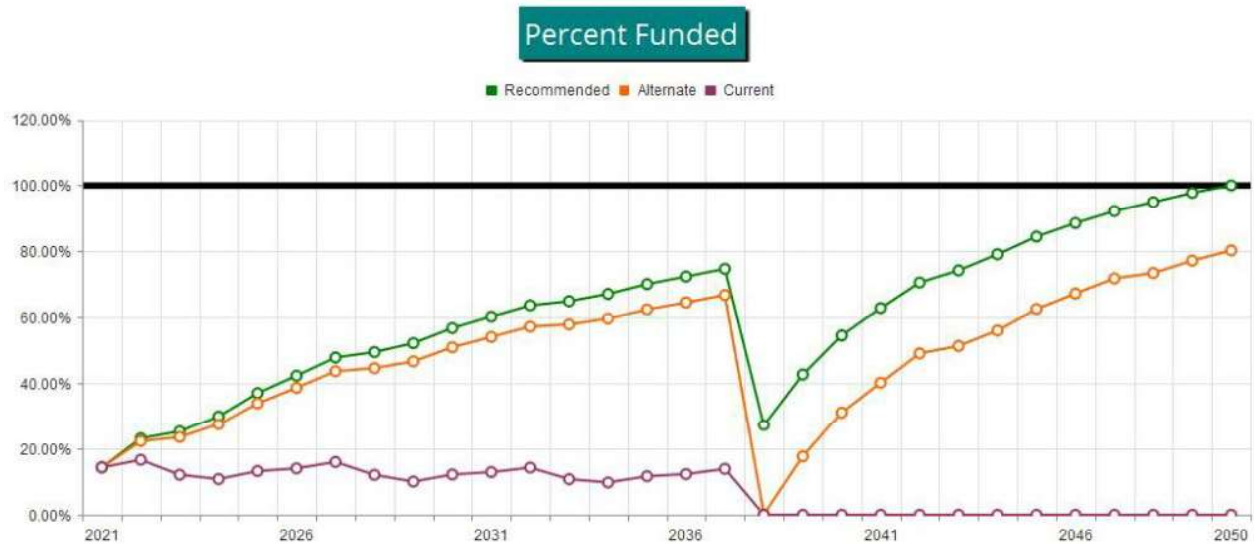
Figure 4

This figure shows the same information plotted on a Percent Funded scale. It is clear here to see how your Reserve Fund strength approaches the 100% Funded level under our recommended multi-yr Funding Plan.

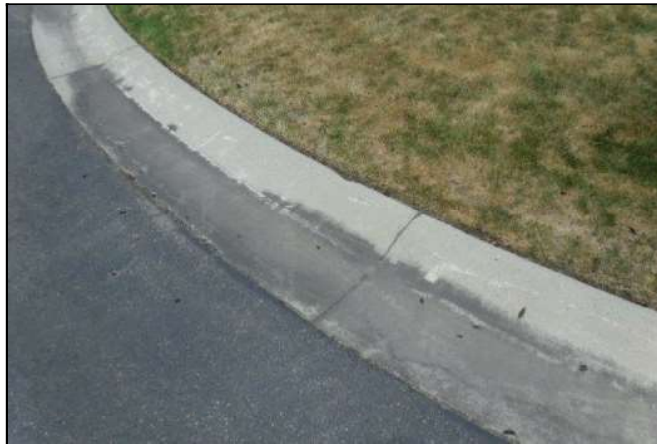
**Comp #: 100 Concrete - Repair/Replace**

Comments: Concrete appeared in generally intact condition at the time of our site visit.

As routine maintenance, inspect regularly and pressure wash for appearance. Repair any trip hazards (1/2" difference in height) immediately to ensure safety. Repair promptly as needed to prevent water penetrating into the base, which can cause further damage. Factors affecting the quality, service life of the concrete include; the preparation of the underlying soil and drainage, thickness and strength of concrete used, steel reinforcement (none likely), amount and weight of vehicle traffic, if any and tree roots nearby.

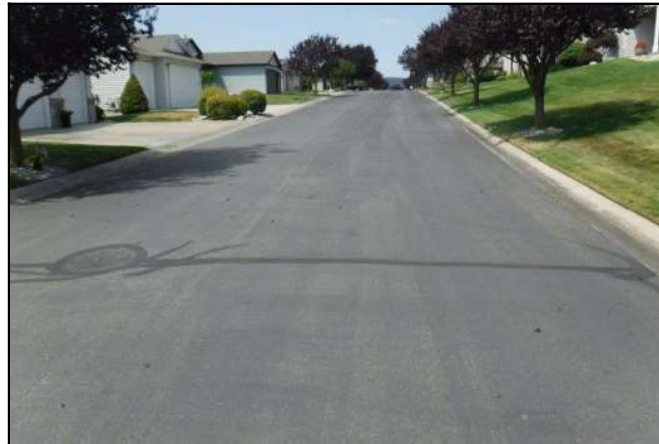
Comments: Asphalt appeared generally intact at the time of our site visit. Association records indicate that asphalt was repaired in 2019 at a cost of \$601.13.

Useful life below assumes regular seal coating and repairs (see component #121). The lack of seal coating and repairs can greatly decrease the asphalt's useful life. Resurfacing is typically one of the larger expense items in a reserve study. When need to resurface is apparent within a couple of years, consult with geotechnical engineer for recommendations, specifications/scope of work and project oversight.

As routine maintenance, keep surfaces clean and free of debris, ensure that drains are free flowing, repair cracks, and clean oil stains promptly. Assuming proactive maintenance, plan to resurface at roughly the time frame below.

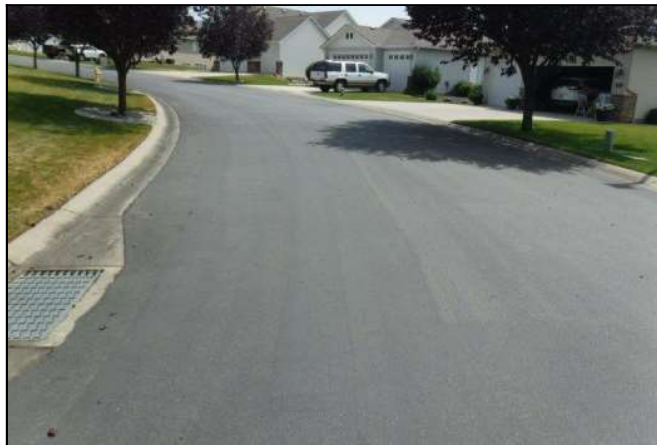
Comments: Asphalt seal coat was beginning to show signs of deterioration at the time of our site visit. Our source reported that asphalt was last sealed in 2017 at a cost of approximately \$17k plus tax.

Repairing asphalt before seal coating is imperative. Surface preparation and dry weather during and following application is key to lasting performance.

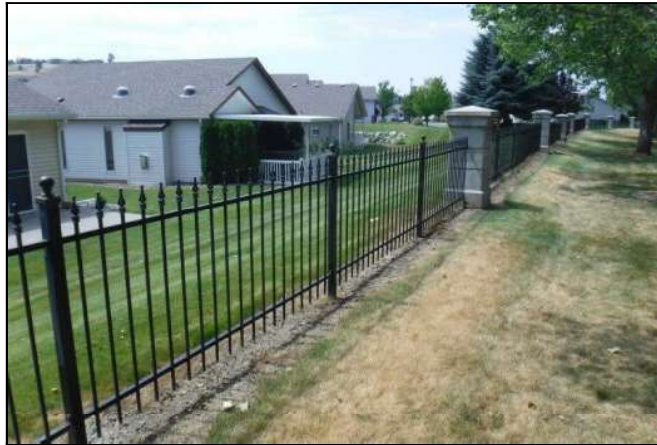
**Comp #: 143 Metal Fence - Replace**

Comments: Metal fencing appeared generally intact, with no obvious areas of instability or damage noted during our limited visual review.

We suggest planning for total replacement at approximately the time shown below. As remaining useful life approaches zero years, evaluate the fence and adjust life accordingly.

Routinely inspect for stability, security, and appearance. Repair locally as needed as part of general maintenance.

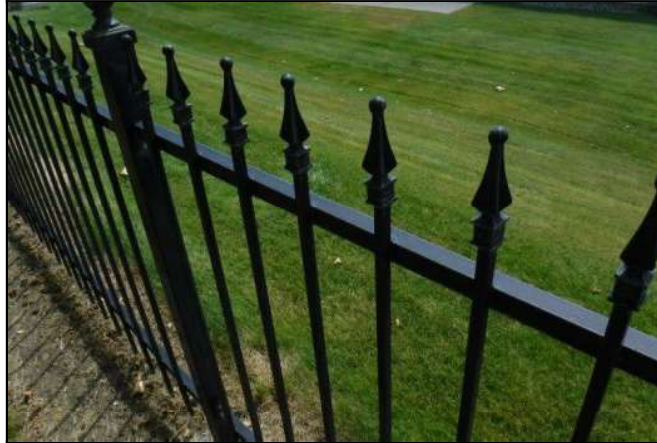
Comments: The painted metal fence appeared to be in generally intact condition during our limited visual review.

Touch up paint, and secure any fasteners as needed as part of general maintenance. If corrosion is found, apply rust inhibitor to prevent corrosion, and extend the useful life.

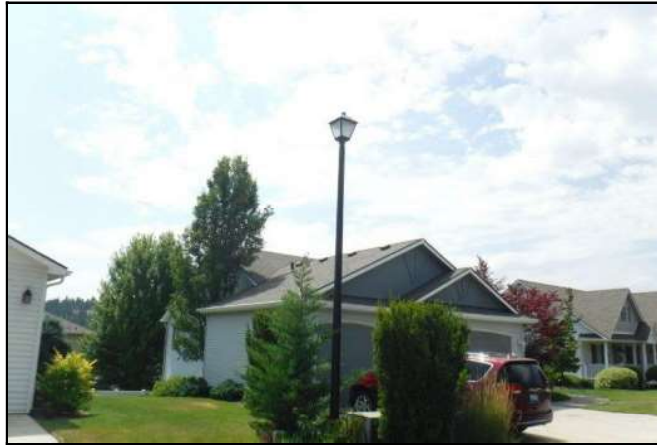
**Comp #: 160 Pole Lights - Replace**

Comments: Our source reported that pole lights are the responsibility of the local utility company to maintain, repair and replace, therefore no reserve funding included.

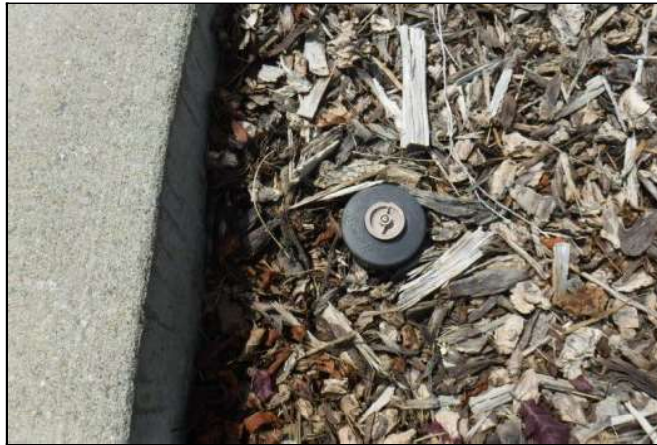
**Comp #: 175 Irrigation System - Repair/Replace**

Comments: Our visual observation of the irrigation system was limited as the majority of system components are below grade. No reports of repairs or problems. At the time of this study, no information (plans and/or specifications) was provided to us regarding the extent of the irrigation system.

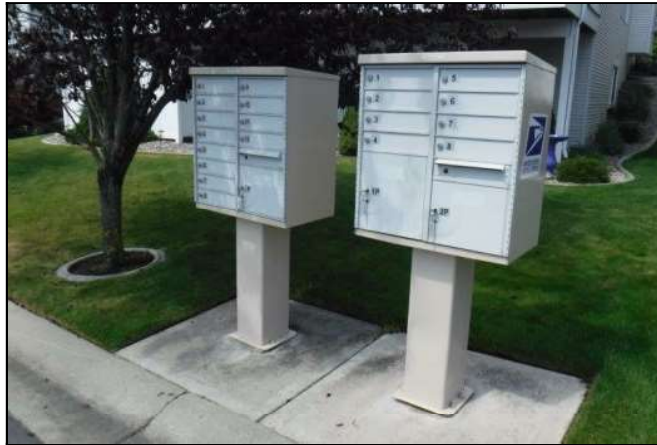
Useful Life:  
25 years

Remaining Life:  
7 years

Best Case: \$ 11,200

Worst Case: \$ 14,400
